Piper Aircraft, Inc.
2926 Piper Drive
Vero Beach, FL, U.S.A. 32960

SERVICE NO. 1345 BULLETIN

SUBJECT:

MAIN WING SPAR INSPECTION

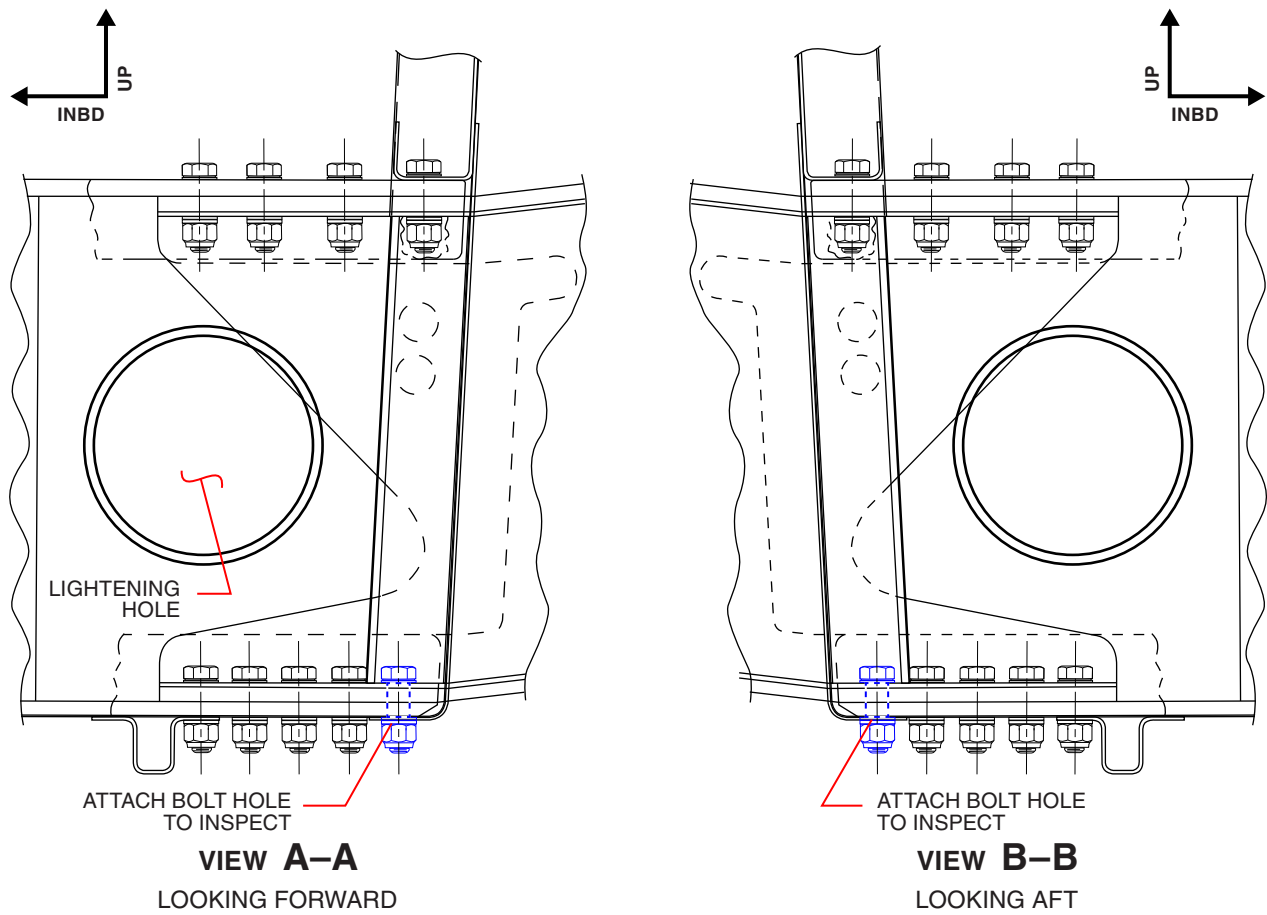
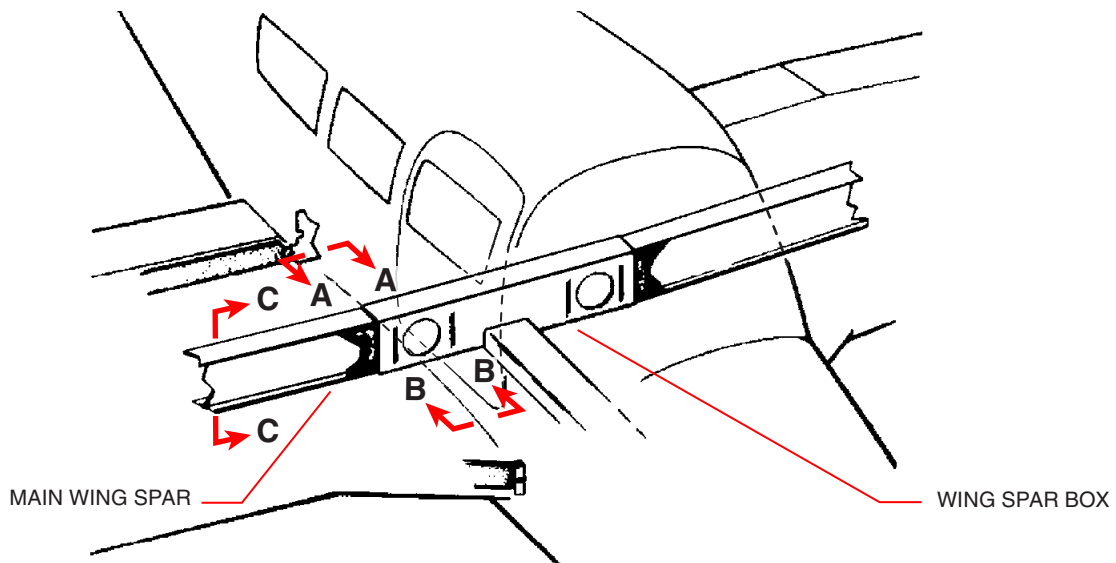
Figure 1, Sheet 1 of 2
Typical Main Wing Spar Attach Bolts and Spar Cross Section (Right Wing Shown)

1. Locate the two (2) outermost main spar attach bolts, as shown in Figure 1, installed on the lower cap of the left and right main spar, on the forward and aft sides of the spar web.

WARNING: Do not drive bolts into or out of the main spar attaching bolt holes (see Views A-A and B-B). Be careful to avoid damaging the bolt holes while removing and replacing the bolts.

2. Carefully remove the two (2) wing spar attach bolts. Discard the bolts and nuts. Retain or replace the washers, depending on condition.
3. Inspect the inner surface of each bolt hole using the eddy current inspection method described above. Figure 1 provides cross sections of the main wing spar showing the bolt holes to be inspected.
4. Fill out the inspection [feedback form \(link\)](#), regardless of the findings.
 - If no cracks are found, return the form to Piper within 10 business days. Proceed to Step 6.
 - If any cracks are found, return the form to Piper within 24 hours (or one business day). Proceed to Step 5.
5. Prior to further flight, replace the wing, spar or spar section, as applicable, with a serviceable unit that has been shown to be free of cracks when subjected to the inspections specified in this service bulletin.

6. Install new bolts and nuts per the applicable Piper IPC. Existing washers in good condition may be reused. Torque the nuts according to the applicable Piper AMM.
7. Make a logbook entry documenting compliance with this service bulletin.

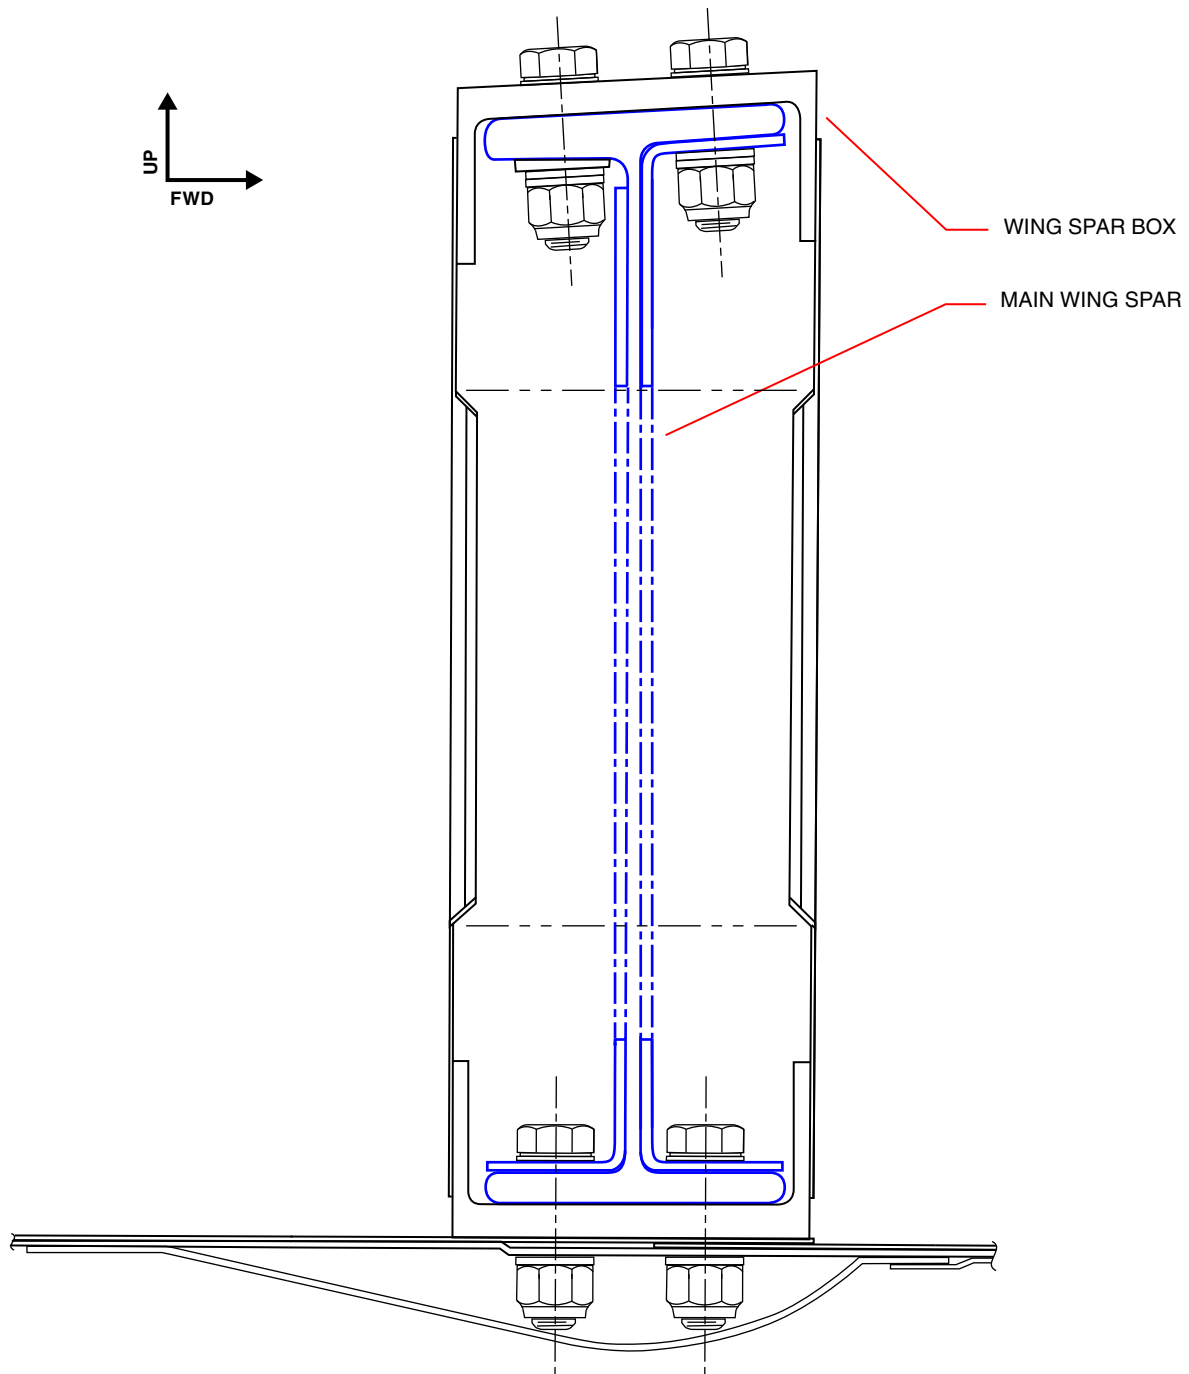
Figure 1, Sheet 2 of 2

VIEW C-C

WING SPAR CROSS SECTION
SHOWN AS INSTALLED IN WING SPAR BOX
